## Summary of Photographs

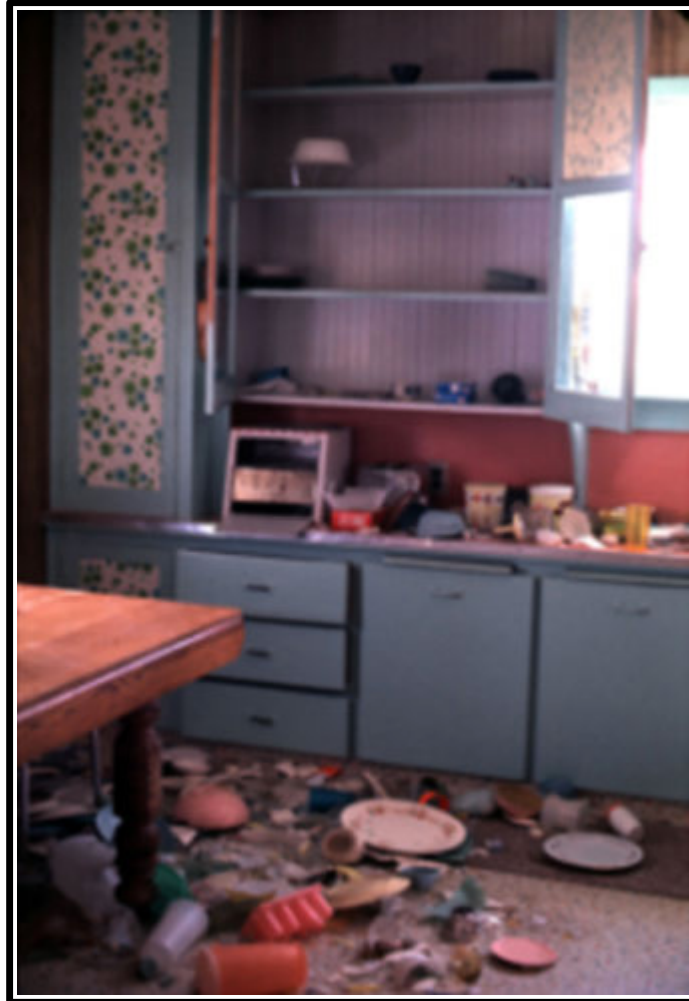
Farmhouses in the Pocatello Valley, a short distance from the Utah border, were hard hit by the earthquake. Many were shifted off their foundations and lost chimneys. Inside, many cabinet shelves were emptied. These homes are only lived in summer and fall when farming is possible in this valley, so no one was there to be hurt during the earthquake.

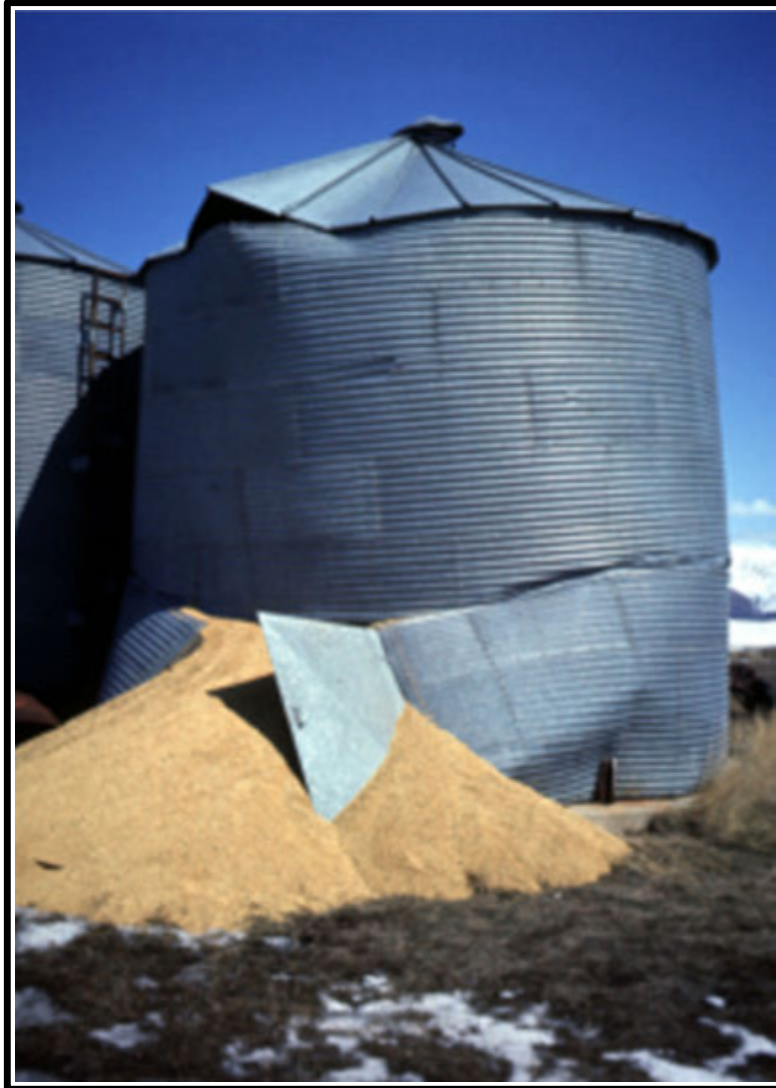
This grain storage bin in the Pocatello Valley was knocked off its foundation and split, spilling grain over the ground.

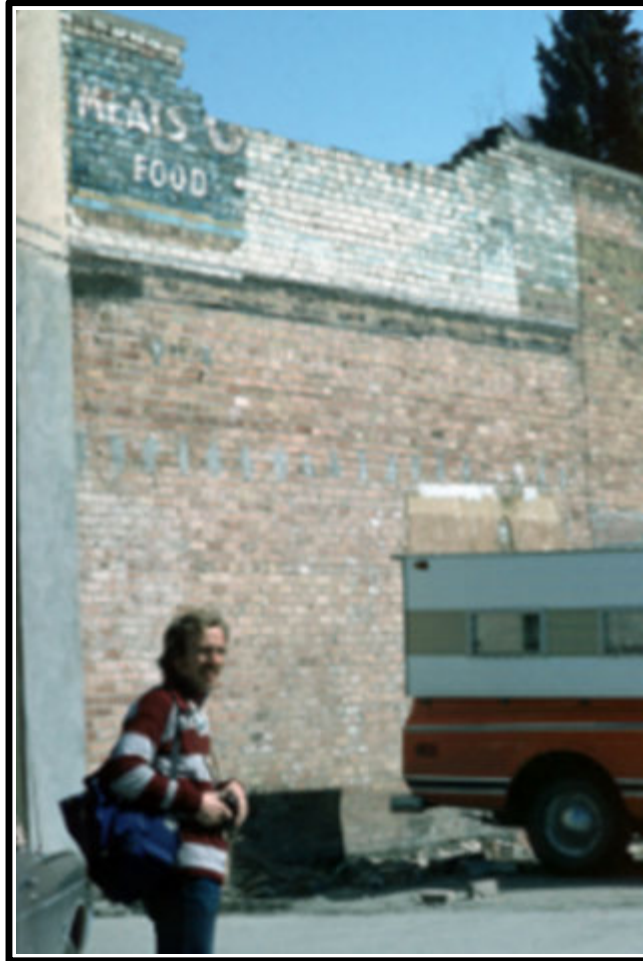
Brick parapet walls are a hazard when the ground shakes. This one fell in Malad City, Idaho, the largest community near the epicenter. Walls and chimneys fell, foundations cracked and windows were shattered.

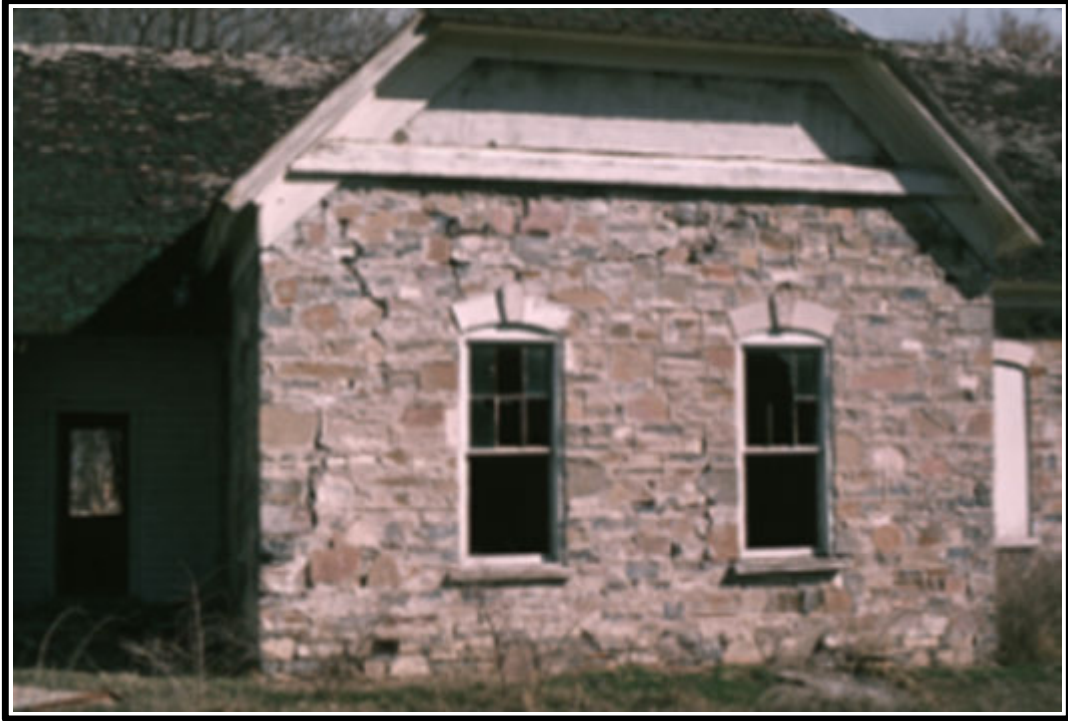
In Snowville, Utah, this stone building was cracked by the ground shaking.

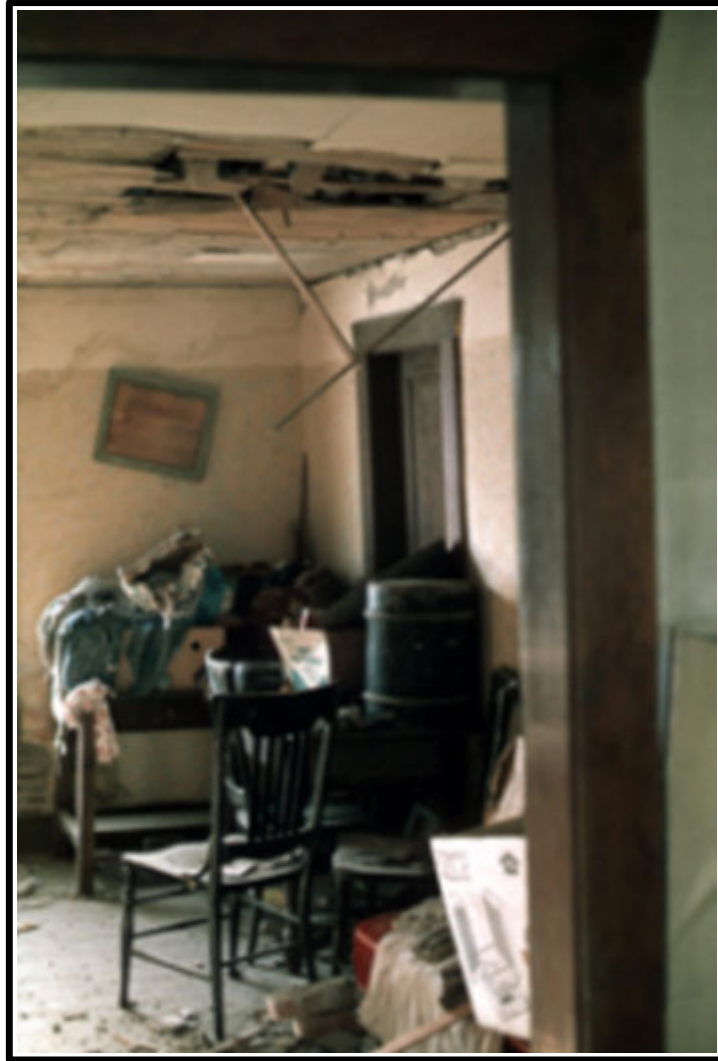
Chimneys are particularly vulnerable to ground shaking. In Ridgedale, Idaho, the chimney fell through the roof of a home.

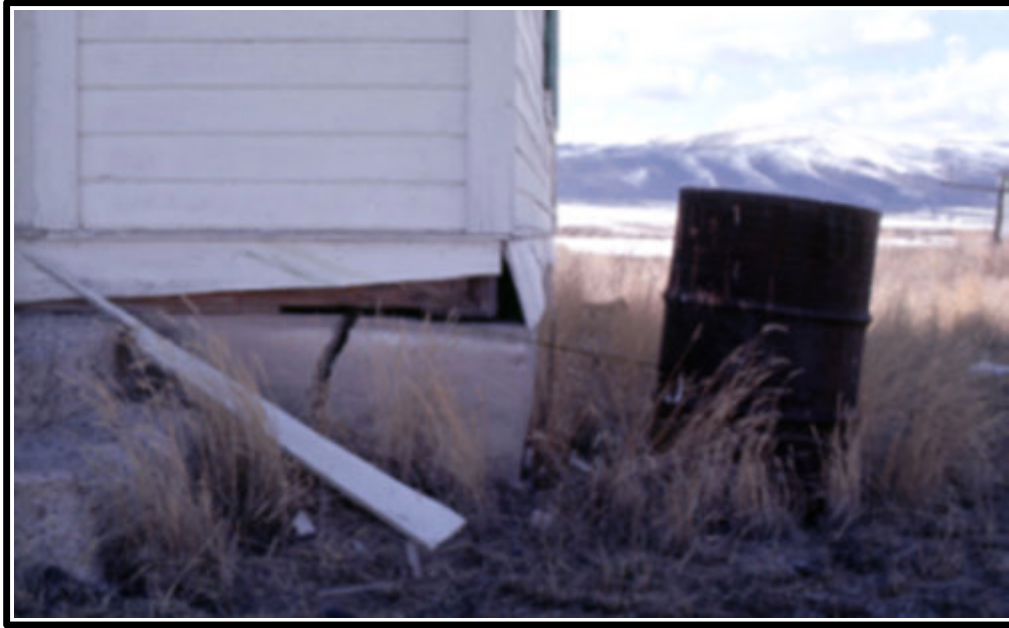
This farmhouse in Ridgedale, Idaho, had its foundation severely cracked during the earthquake.

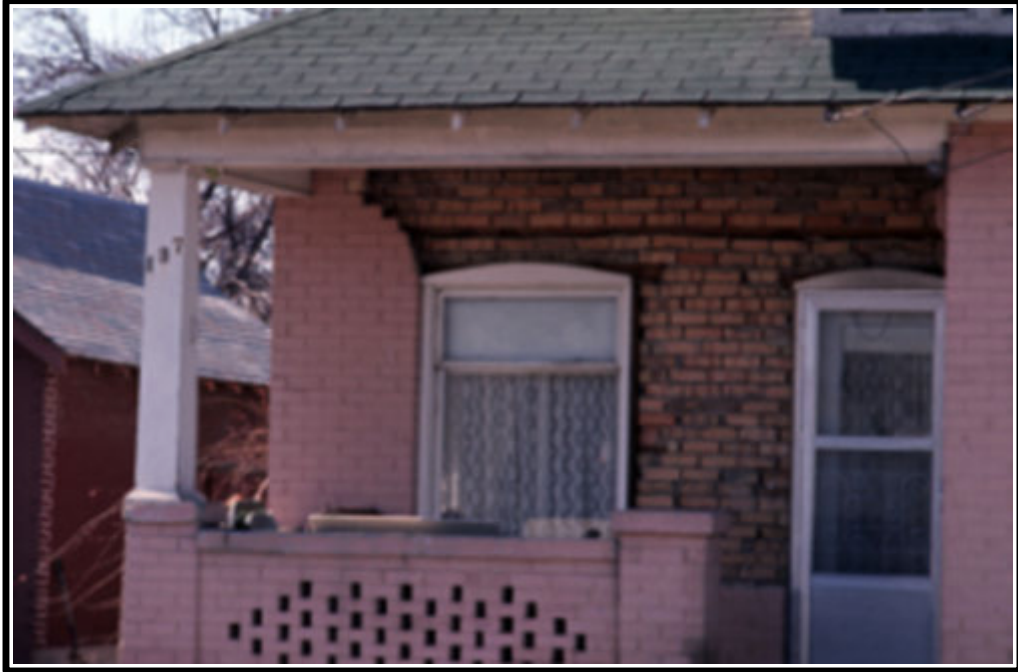
In Malad City, Idaho, the brick facade was stripped off the front wall of the Thorp home and landed on the porch. Inside, irreplaceable antiques were smashed.

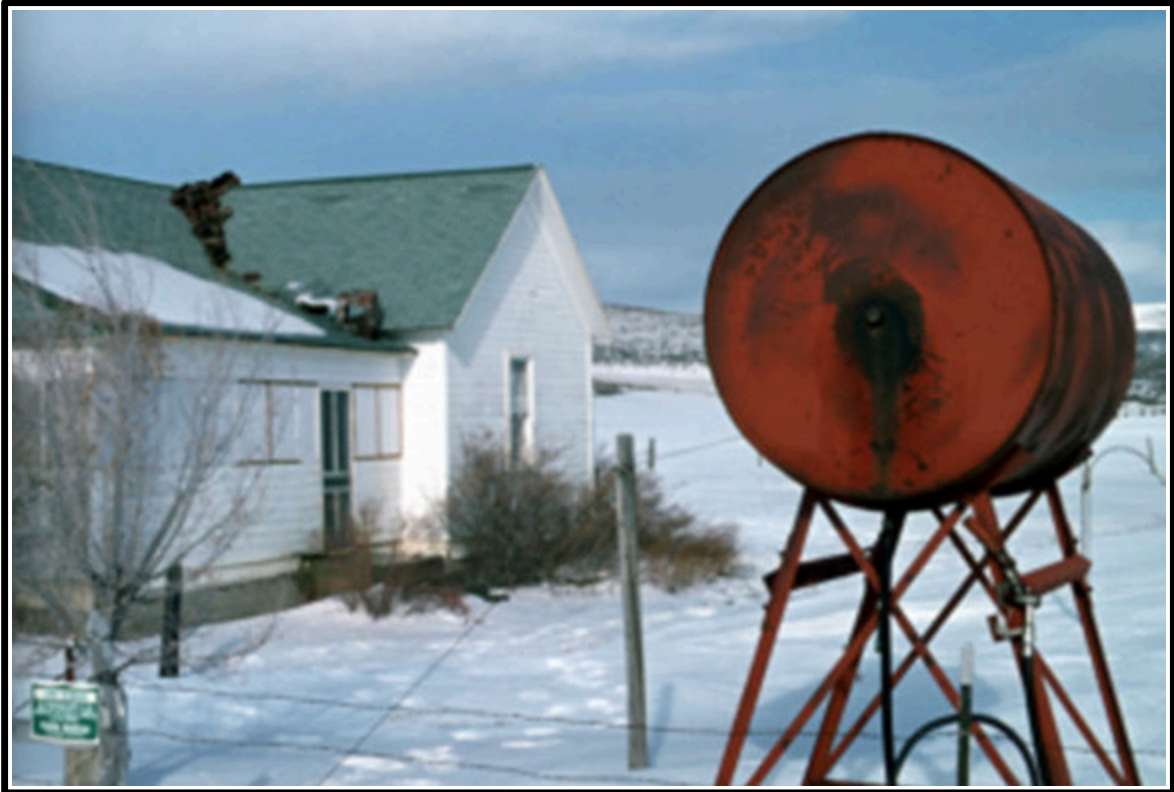
Chimney bricks dropped onto the roof and front porch of this farmhouse located in Pocatello Valley, Idaho.

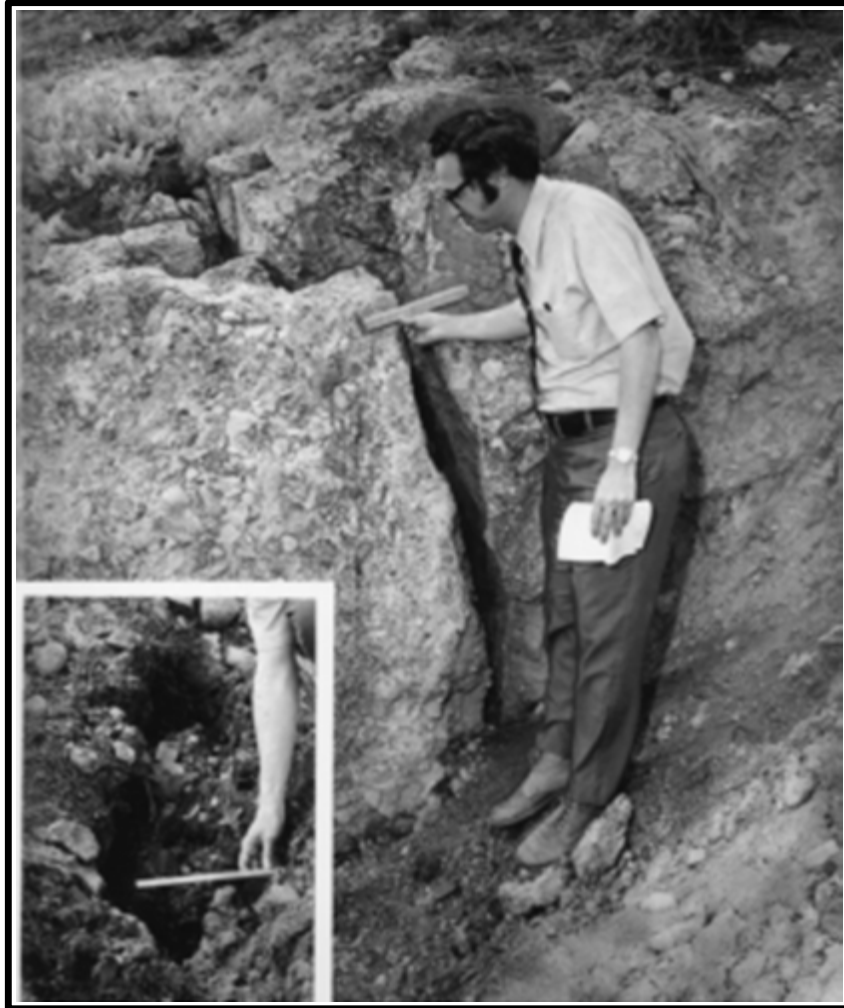
Dr. Bruce Kaliser, geologist with the Utah Geological and Mineral Survey, examines a ground crack along the north bench of Salt Lake City believed to have been caused by the earthquake. Photo by W.C. Johnson.

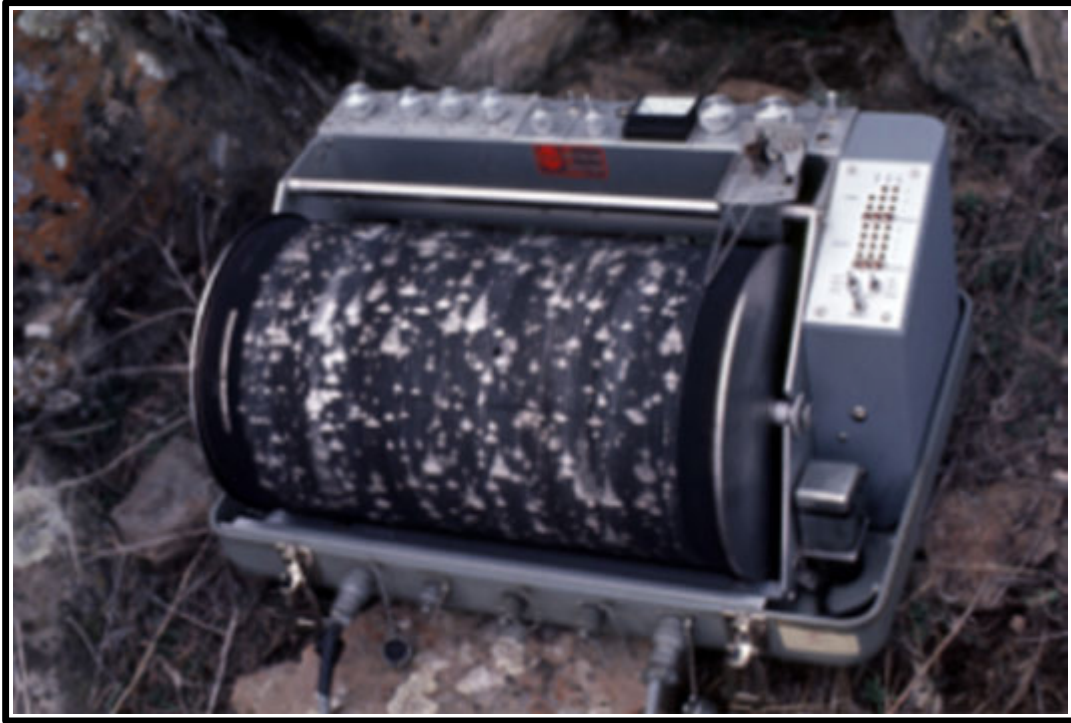
Eleven portable seismographs were quickly set up in the epicentral region by the University of Utah Seismograph Stations. Data recorded by these instruments contributes to a better understanding of the area's geologic structure and earthquake potential.

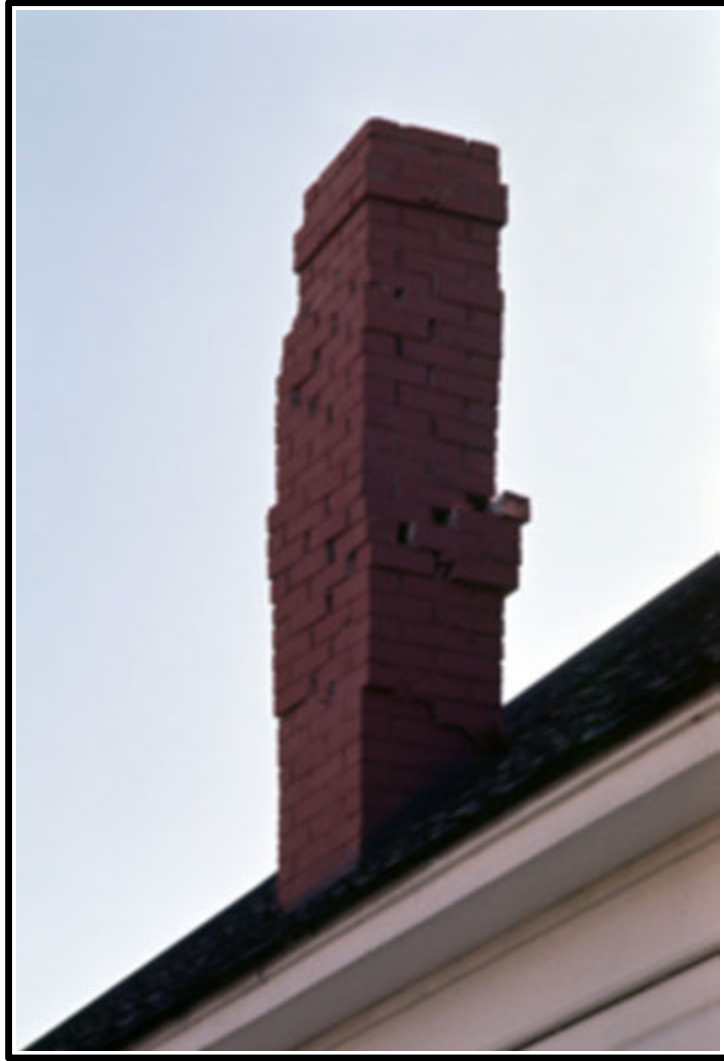
This chimney did a shimmy shake during the earthquake, but did not fall. Chimneys pose a significant threat to structures and the people below them.
